# WALKING AUDIT FOR THE CITY OF GLEN COVE

PREPARED BY VISION LONG ISLAND FOR AARP  
SPRING 2020

## GLEN COVE

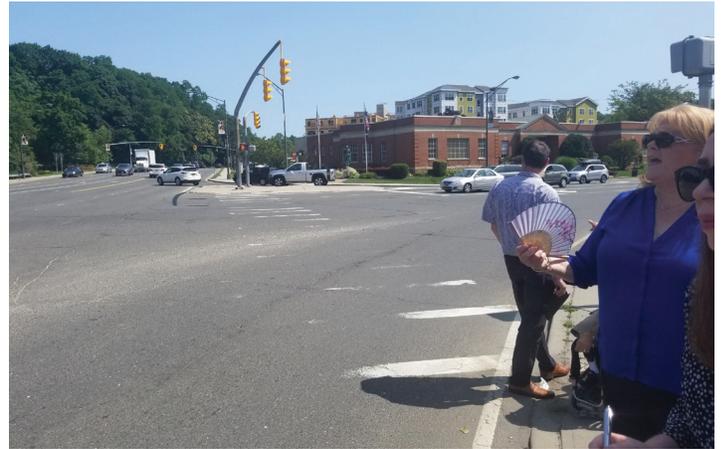
Pratt Boulevard and Glen Cove Avenue

4. Walking along Pratt Boulevard toward Glen Cove Avenue sidewalks were of minimal width and not adequate for the size of our group. There were only a few street trees for shade. At the intersection of Glen Cove Avenue, there are no crosswalks to get to the other side of the road even though the library and post office are adjacent to the intersection. The closest crosswalks are a block away to the north (over 300') and two blocks away to the south (over 700'). The distance from curb to curb is 97 feet

At Glen Cove Avenue and Brewster Street, crosswalks should be added across Brewster Street to allow crossings between new development west of Brewster and library and post office on the east side. In addition, tighten the curb radius at southeast corner and consider elimination of slip lanes to turn right onto Brewster and replace with conventional right turn lanes. Finally, consider tightening the curb radius at southwest corner of Charles Street to shorten crossing distance for pedestrians and calm traffic heading north. Consider inclusion of a bike lane to facilitate non-motorized travel between Garvies Point Development and downtown Glen Cove

Given the high traffic volumes, number of turning movements and skewed geometry of this intersection, it will likely never be comfortable for pedestrians to cross however, currently it is impossible to get across Brewster. The timing of lights in the area should be investigated to see if it is possible to coordinate them to require less stacking at each intersection which increases the number of lanes needed to store all of the vehicles. This will allow more flexibility in reducing the amount of space dedicated to motor vehicles. In the mean time, reducing the speeds that drivers pass through the intersection and make turns will improve safety for those on foot.

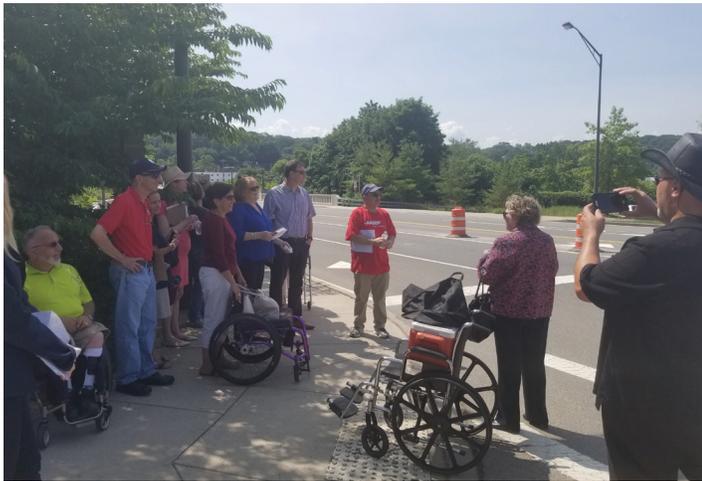
become a busy intersection for both vehicles and people is completed. The slip lane also allows for faster turns make it easier for drivers. The group then turned right on park rather than take the sidewalk along Herb Hill. The path through the park was noticeably more comfortable than other sidewalks around downtown.

5. The intersection at Herb Hill Road and Charles Street had faded road markings and large curb radii that allow for faster right hand turns than is safe. There wasn't much traffic during our time there, but it is anticipated to become a busy intersection for both vehicles and people on bikes and on foot once construction of Garvies Point and gives pedestrians a more complicated crossing to Herb Hill Road and took the pedestrian path through the

traffic lights at Brewster are far enough away that they don't back up into the roundabout. A Dutch style roundabout with separated bike lanes through the roundabout will make it even safer if designed properly.

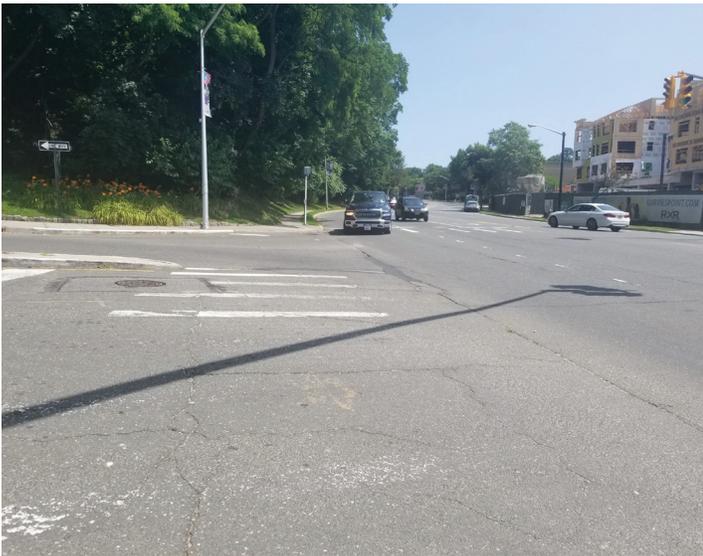
Herb Hill Road, Mill Hill Road and Brewster Street

6. The intersection of Herb Hill, Mill Hill and Brewster Street is complicated in difficult to navigate. The crosswalk striping was faded away in many locations and motorists were travelling quickly. There is a small island in the middle of where Herb Hill and Mill Hill meet, however the island is too small to provide pedestrian refuge and creates a confusing and potentially dangerous situation. It is 68' from curb to curb with no crossing signal for the north-south crossing, only for the east-west crossing on the north

side of the intersection. The entrance to Panera also appeared to be wider than necessary. The entrance to the new development under construction was not yet built at the time of the walk. The group continued north along Brewster past several multi-family buildings. The sidewalk was narrow and had only a few shade trees.

At the intersection of Herb Hill and Brewster, the intersection needs to be simplified to reduce potential conflict points. Mill Hill should separate from Herb Hill away from the intersection with Brewster. This will allow the crossing at Herb Hill to be much shorter and safer. Since this point is a critical connection between

Garvies Point and downtown, pedestrian and cycling connections through this intersection and up to School Street need to be made as safe and comfortable for those on foot or bikes in order to encourage non automobile travel between the two areas.

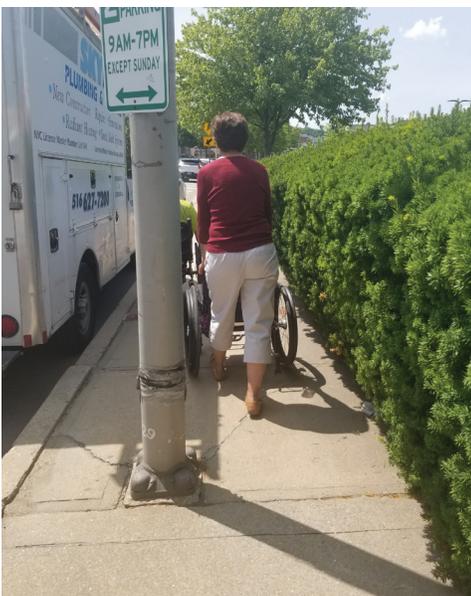
School Street in front of shopping center

7. At the intersection with Cottage Row, the crossings were 75' and 76' long with 25 seconds given to cross. There was a slip lane to make a right onto Brewster from Cottage and no crosswalk on the south side of the intersection. The island dividing School Street at the intersection did not extend far enough to provide a pedestrian refuge. The group then continued down School Street towards Glen. The sidewalk in front of the shopping center was narrow and the hedge and sign and utility poles encroached into the pedestrian

space making it difficult or impossible for those in a wheelchair or pushing a stroller. At Highland Road, the group crossed to the other side. The crossings were 44 feet across School Street and 31 feet across Highland. Both locations were given 13 seconds to cross.

hedge should be trimmed back to allow more space along the sidewalk.

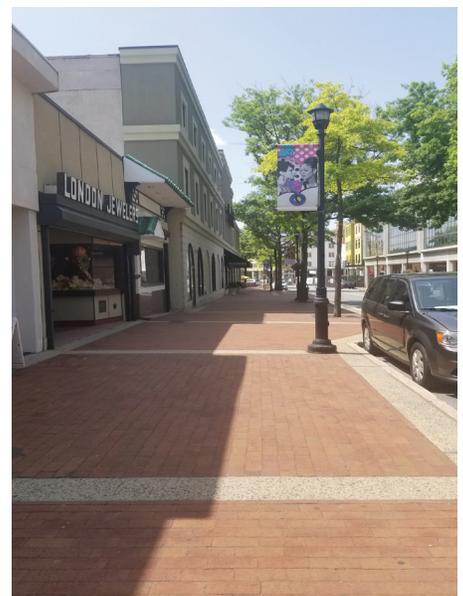
School Street approaching Glen Street

8. The group continued south on School Street to the intersection of Glen Street. The construction on the west side made it impossible to cross the street, but it was observed that the intersection had an incredibly large turning radius making the intersection very wide.

At the main intersection of School Street and Glen Street, the overly wide intersection can be narrowed with bulbouts at the southeast corner and reducing the turning radius at the northeast corner to slow drivers down when making right hand turns. There may also be room for a mini traffic circle in the middle of the intersection to further slow turning vehicles, reduce asphalt surface and beautify the center of town.

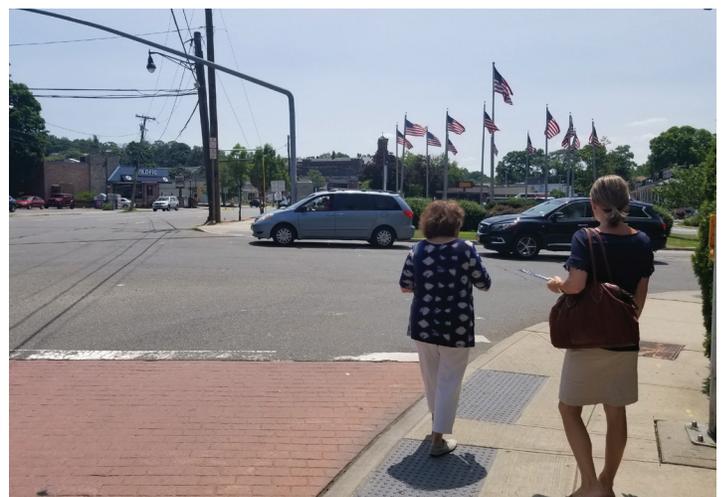
Glen Street and Town Path

9. After the main walk audit ended, several participants visited the Senior Center further east on Glen Street to observe conditions there. There was a 36' long crossing near the center to the parking lot across the street. Further east where Glen Street becomes a county road, it widens significantly and there is a very challenging intersection to cross at Town Path. The crosswalk striping was faded and the slip lane to head east on Glen Street from Town Path allows cars to turn at high speeds. There was 80 feet from curb to curb across Glen Street and 56 and 60 feet across the western portion of Town Path, there was no crossing on the east side of the intersection. At the slip lane, there is a 20 foot crossing with faded striping and the stop sign is at the far side of the crossing. There is no protection for pedestrians crossing at that location. There is a grocery store and pharmacy in this area that are frequented by senior residents without a safe way to walk to them, the crossings at Town Path and Pearsal Avenue are approximately 850 apart.

Further east on Glen Street, where it becomes a county road at Town Path, a roundabout may be possible to calm traffic as it enters the downtown area. If this is not feasible, the curb radii should be reduced at the intersection and crosswalks striped on all sides of the intersection. The other branch of Town Path that runs along the south side of the triangle should be narrowed to reduce speeding and make it easier to cross. The slip lane to head south on Glen Street should be eliminated and pedestrian crossing signs should be added at the crosswalk. If parking is needed along the south side of the triangle it should be striped to visually narrow the road.
