# WALKING AUDIT FOR THE CITY OF GLEN COVE

PREPARED BY VISION LONG ISLAND FOR AARP  
SPRING 2020

## GLEN COVE

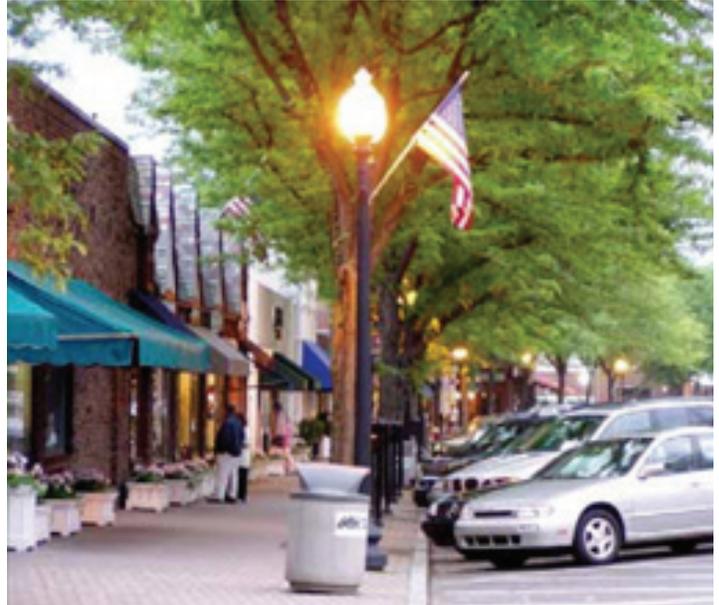
Street trees providing shade and traffic calming

In order for street trees to be effective for traffic calming and improvement of pedestrian safety and comfort, species should be chosen that provide a canopy over the sidewalk and street. If there are no overhead powerlines present, larger varieties should be used to provide the maximum canopy and shade. They should be planted between storefronts whenever possible to minimize blocking the signage of stores. The species should begin branching high enough to not encroach on pedestrian space on the sidewalk and not be hit by trucks in the street.

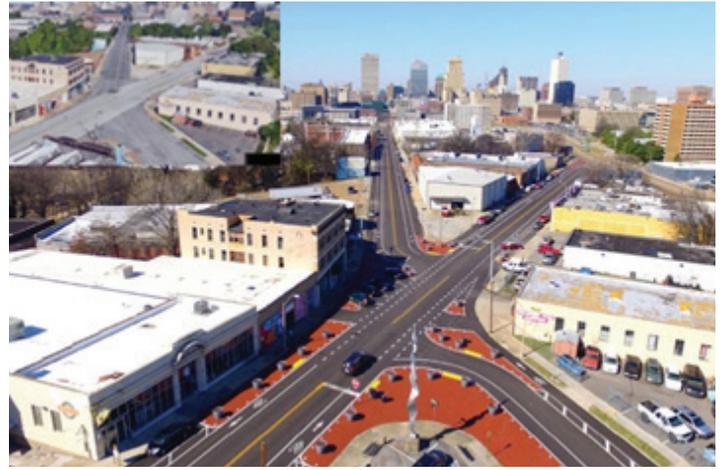
Lower cost intersection modification with paint and planters

need to be modified if actual volumes are significantly different than estimated/assumed volumes. The several large intersections surrounding the core downtown area are most in need of modification to improve safety, walkability and connectivity between downtown and the surrounding neighborhoods. Other more minor changes may be sufficient for some of the smaller roads and intersections. Since large intersection changes may be too expensive to implement quickly, interim changes with paint, plastic bollards and other low cost materials can be used to improve safety until funding is available for more substantial improvements. The photo shows the transformation of an intersection with paint and planters.
